DRAFT FINAL
Specific Site Assessment for
Coal Combustion Waste
Impoundments at Arizona
Electric Power Cooperative
(AEPCO) Apache Power Plant
Cochise, Arizona

Submitted to:
Lockheed-Martin Corporation
2890 Wood Bridge Avenue
Building 209 BAYF
Edison, NJ 08837

Submitted by:
GEI Consultants, Inc.
6950 South Potomac Street, Suite 300
Centennial, CO 80112

October 2009
Project 091330

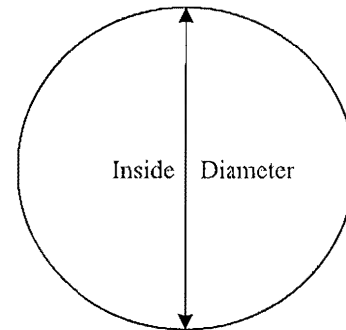
Is water flowing through the outlet? YES X NO _____

(water flow to pump sump is inferred from pump operation)

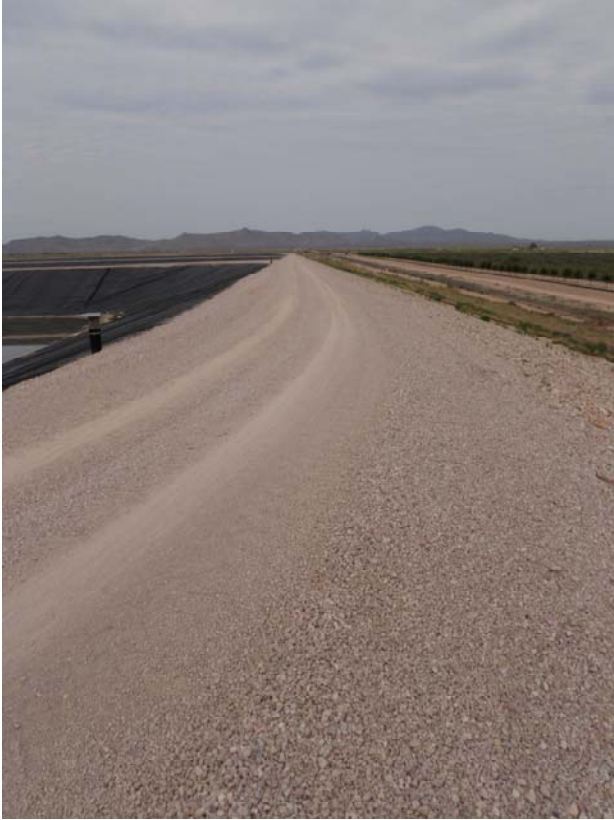
Photo 1: Crest of north embankment of Ash Pond 4 facing west.

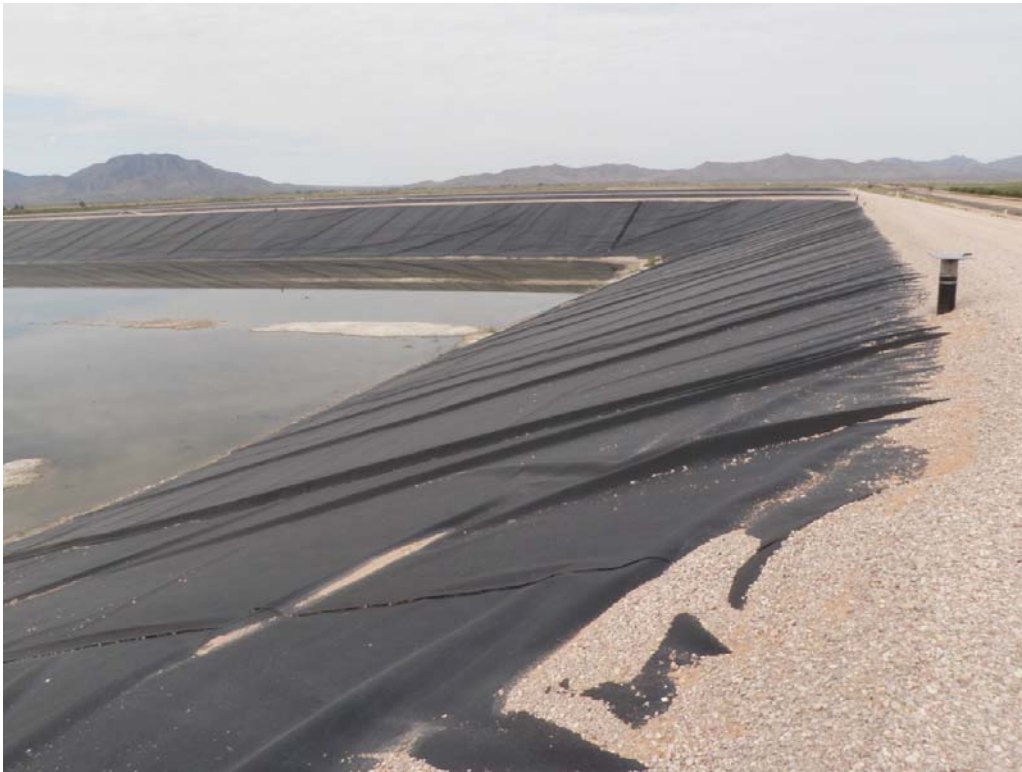
Photo 2: Upstream slope of north embankment of Ash Pond 4 facing west.

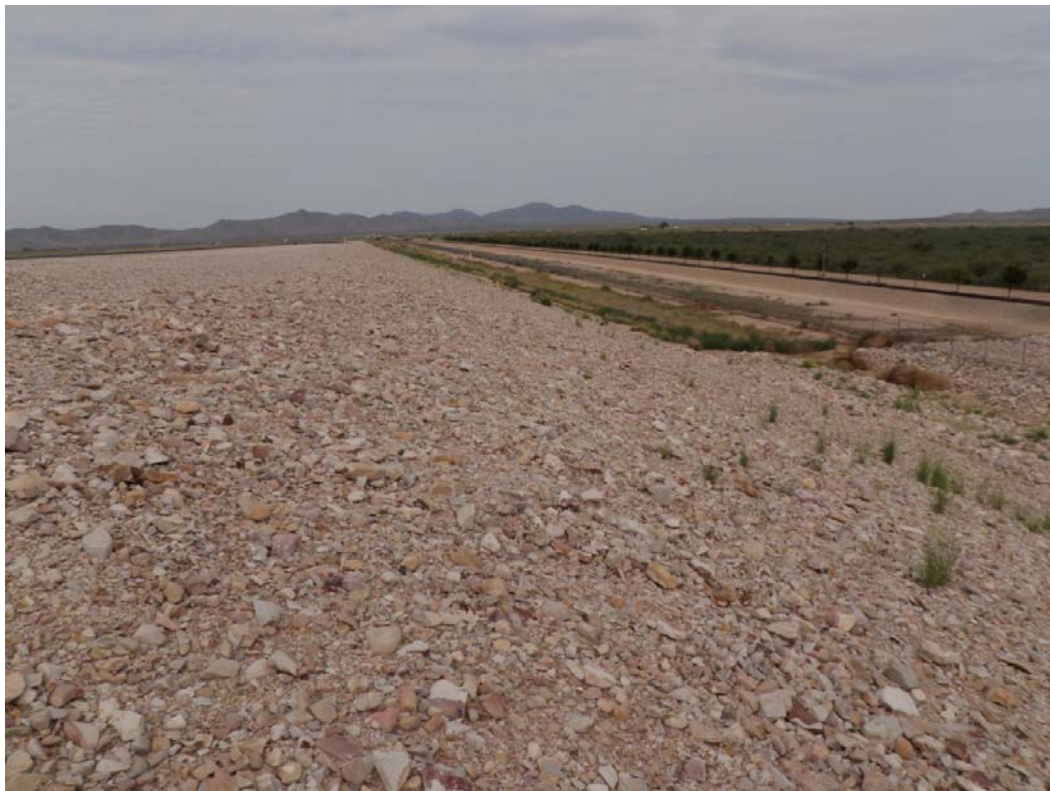
Photo 3: Downstream slope of north embankment of Ash Pond 4 facing west. Note train tracks located to north of facility.

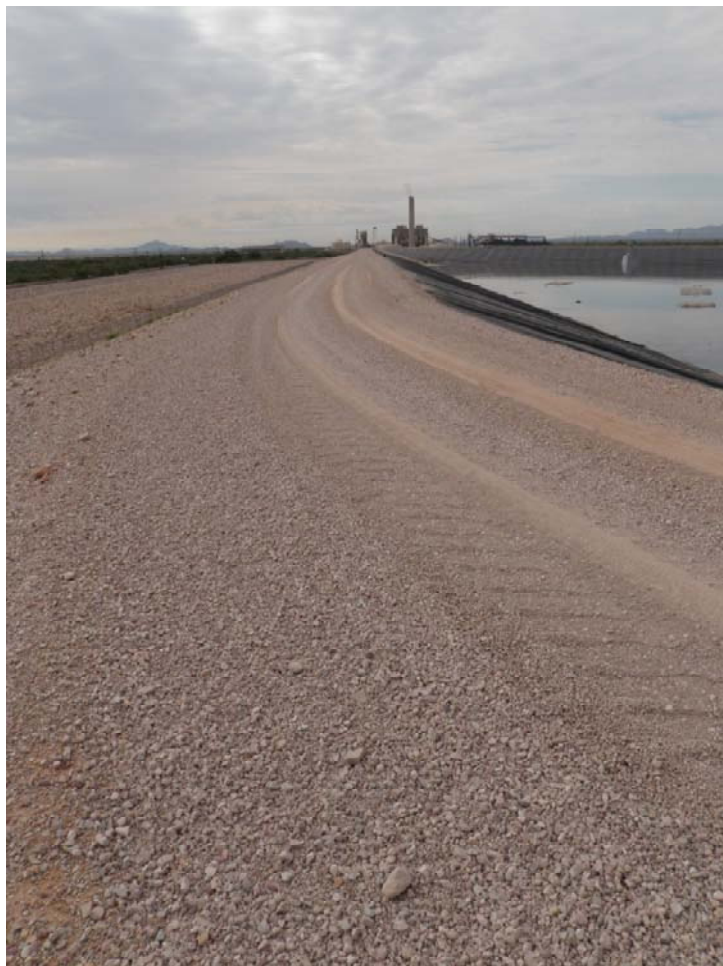
Photo 4: Crest of east embankment of Ash Pond 4 facing south.

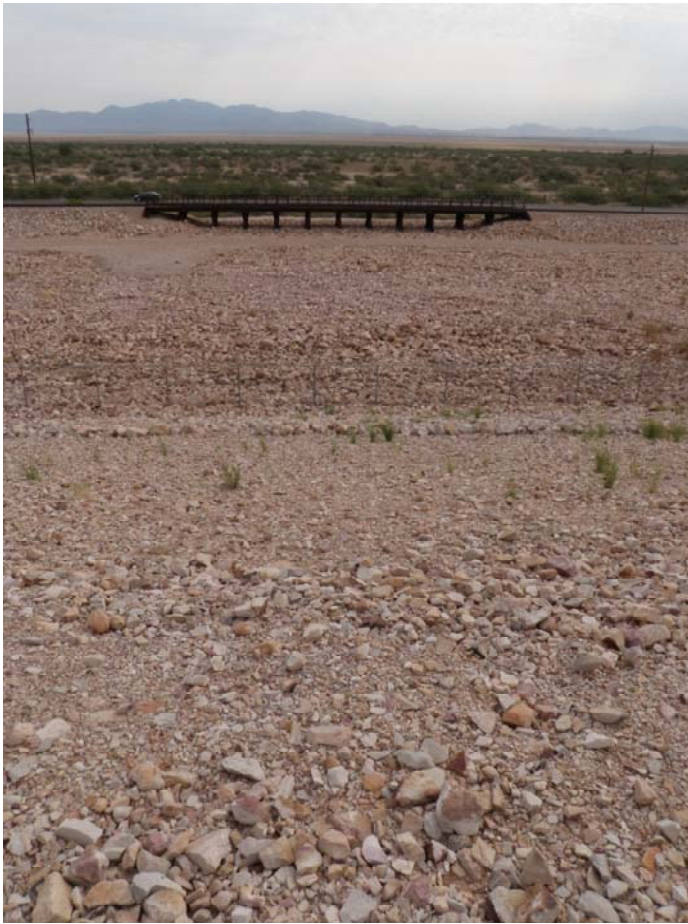
Photo 9: Looking downstream from the east embankment of Ash Pond 4 at the stormwater ditch that discharges to the east through the railroad bridge. Two residences are in the floodway between the bridge and Willcox Playa located further east.

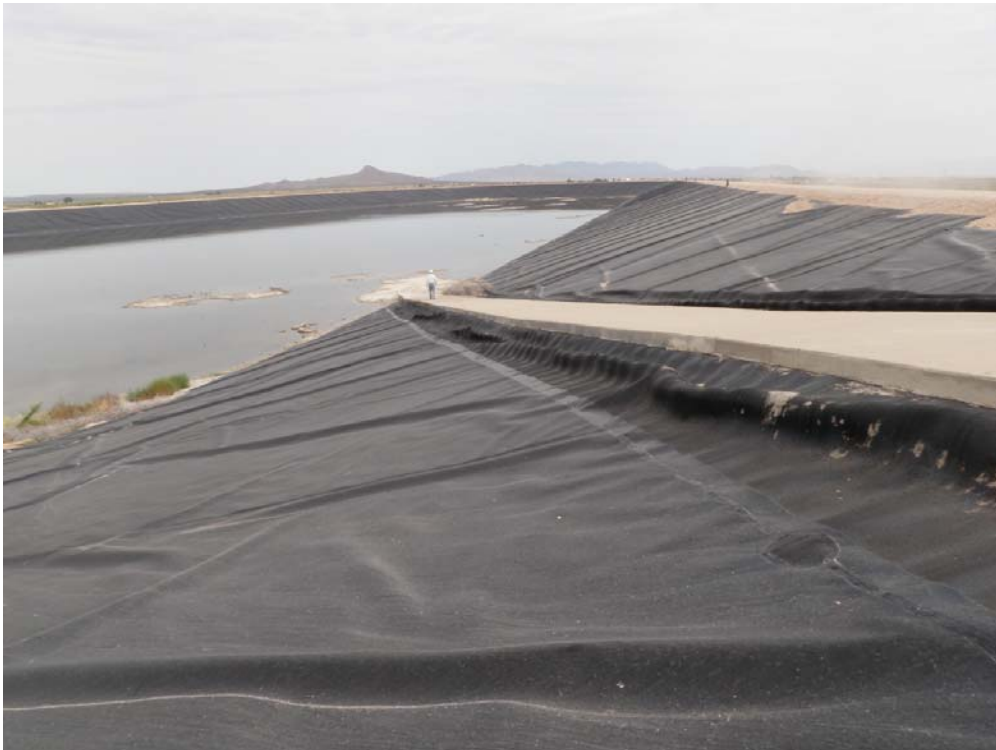
Photo 10: Upstream slope of east embankment of Ash Pond 4 facing north. Note the maintenance access concrete ramp. Pond is nearly empty.

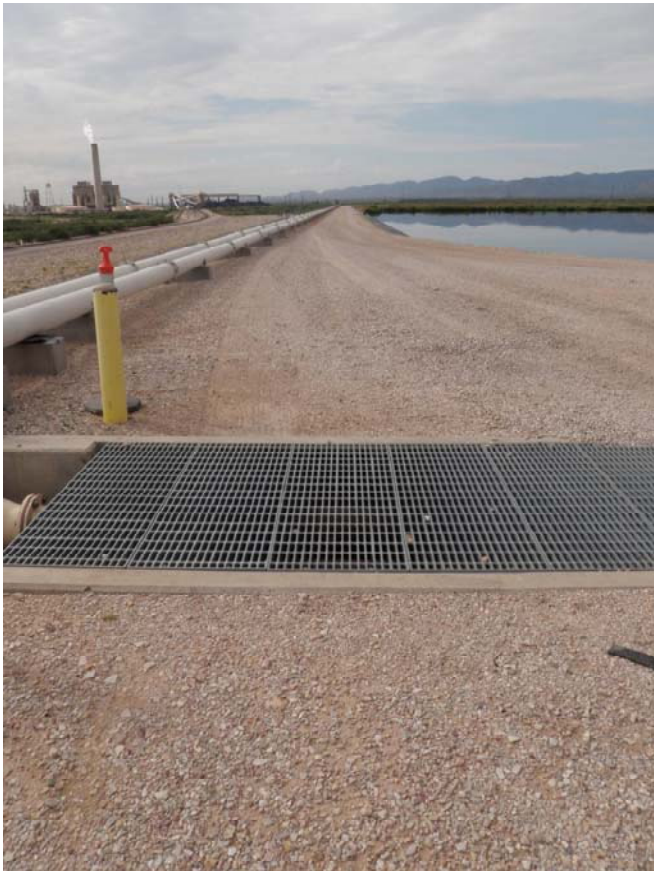
Photo 11: Crest of east embankment of Ash Pond 1 facing south. Pipelines convey slurried fly ash and residuals for disposal in the ash ponds. Note depressed pipe vault for traffic crossing.

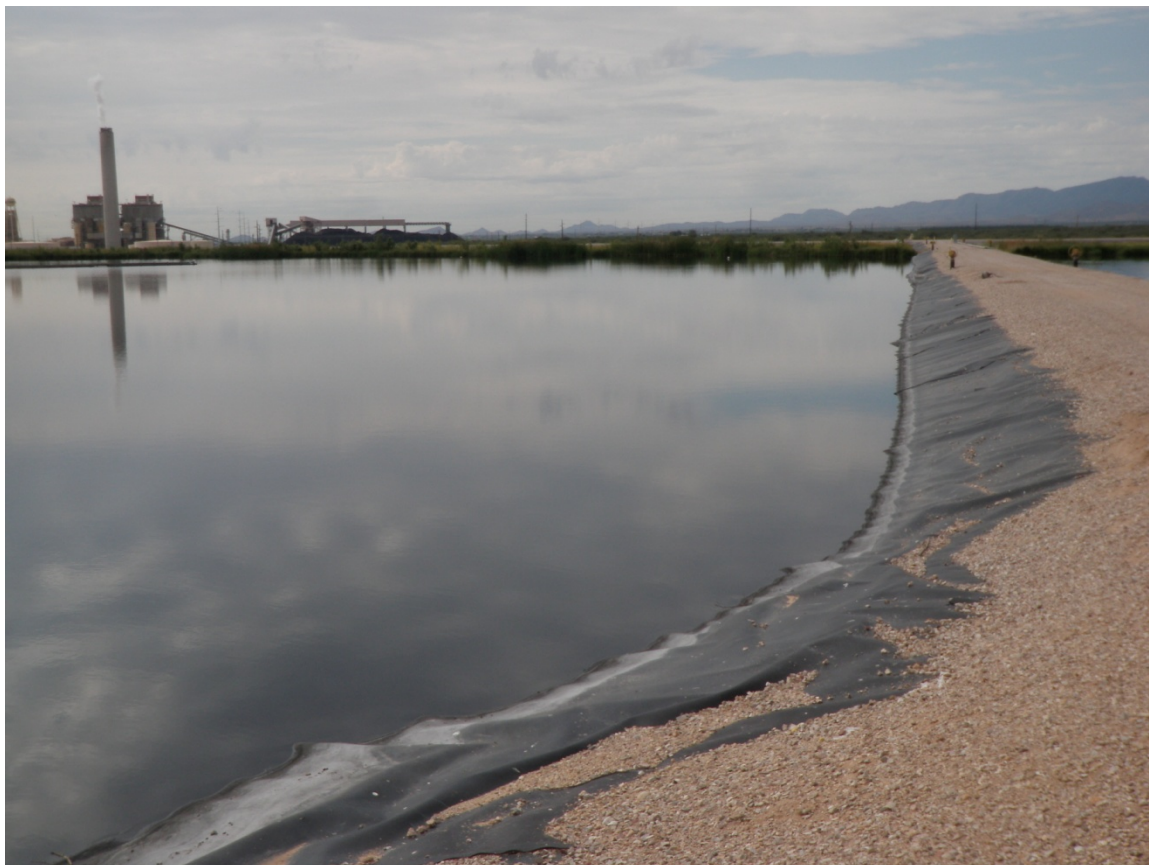
The pond is lined with an 80 mil HDPE lining on the slopes and 60 mil HDPE lining on the bottom, (see Photo 22). The upstream slope could not be observed directly because it is mostly obscured by the HDPE lining. There was no visual evidence of large bulges or depressions beneath the lining that would indicate stability issues. On this basis, the upstream slope was considered to be in acceptable condition.

Photo 22: Upstream slope of west embankment of Ash Pond 1, looking south.

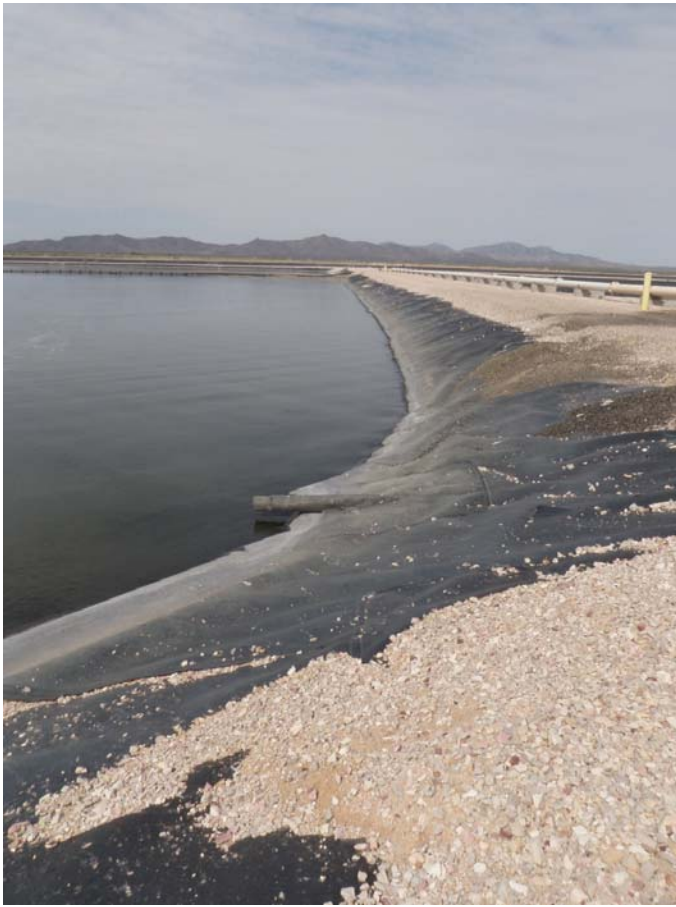
Photo 25: Upstream slope of north embankment of Ash Pond 2, looking west. Note the small pipe that drains a pipe vault.

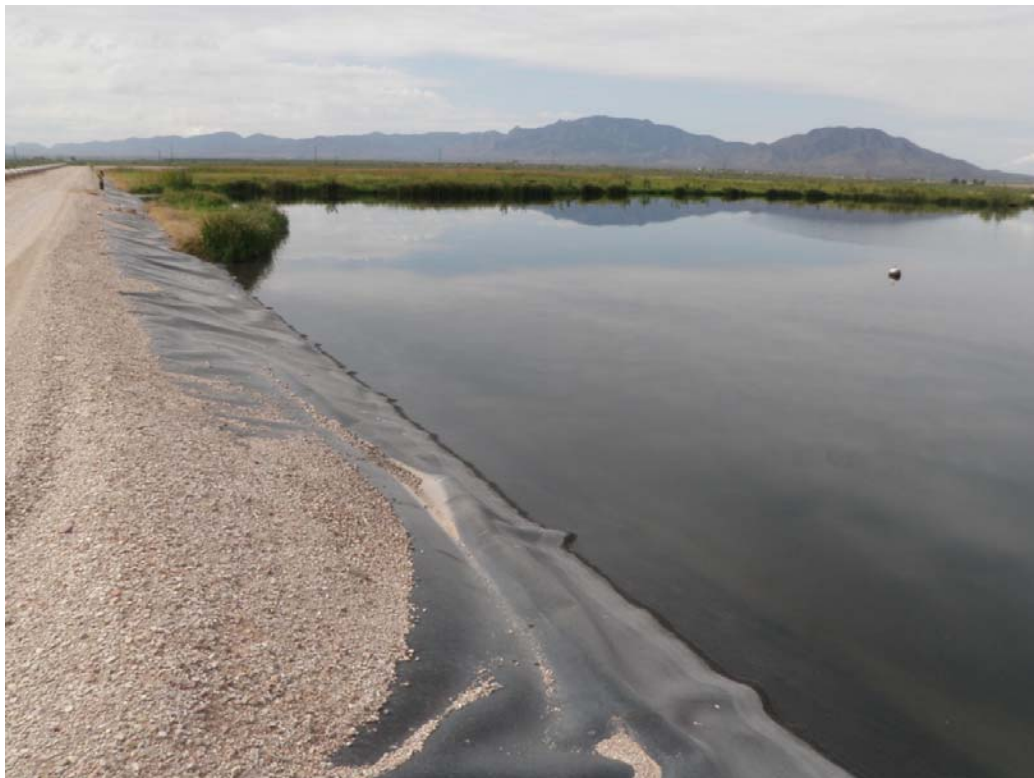
Photo 26: Upstream slope of east embankment of Ash Pond 1, looking south. Note vegetation established on the ash deposits.

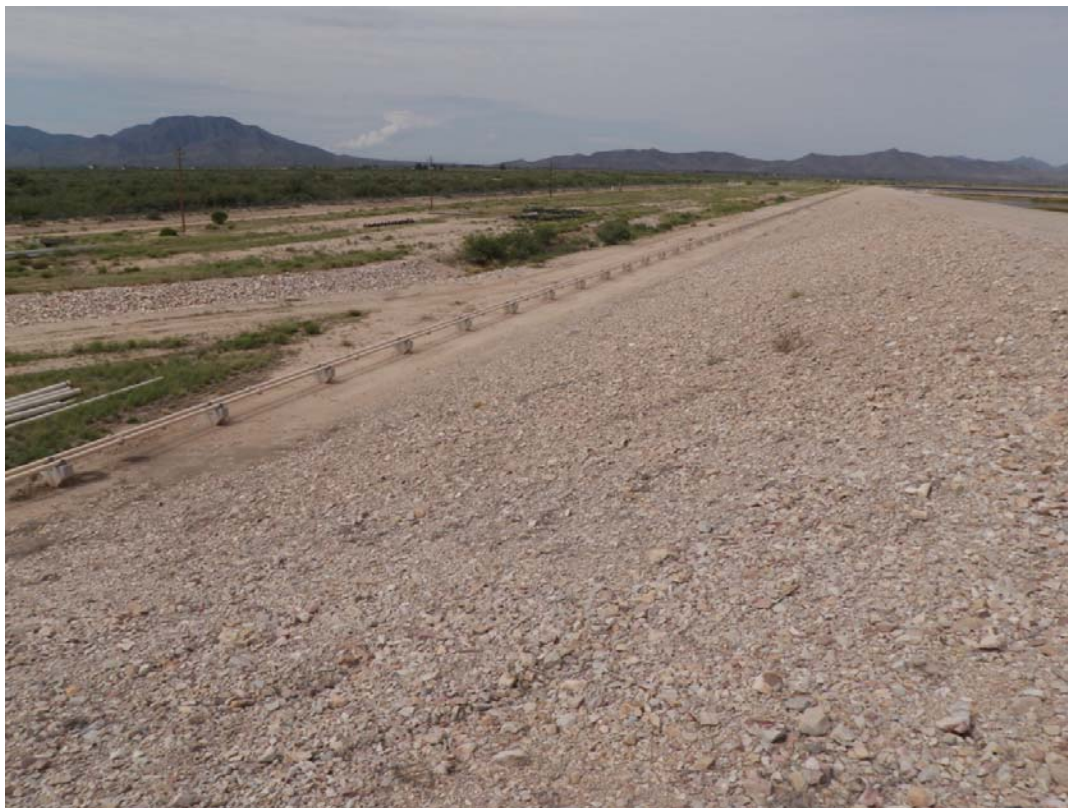
Photo 28: Downstream slope of south embankment of Ash Pond 1, looking west. Note pipes conveying slurried scrubber sludge to Scrubber Sludge Pond 1. Note riprapped stormwater channel located downstream of the embankment.

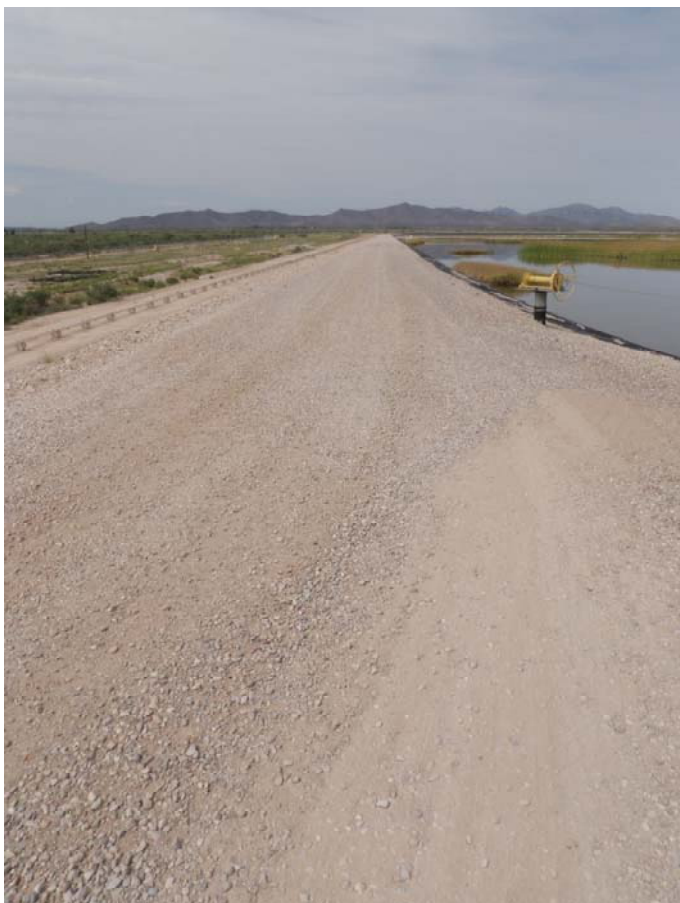
Photo 29: Ash Pond 1 Crest, looking west.

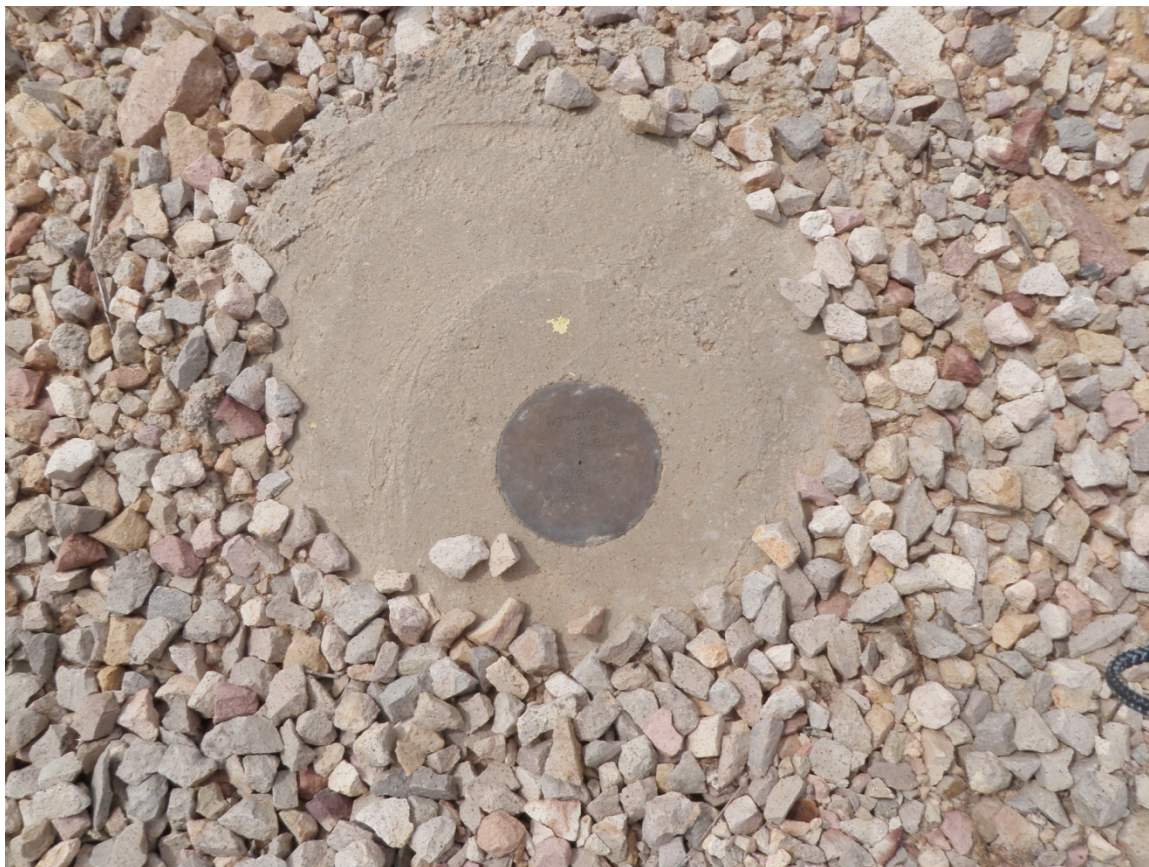
Photo 34: Survey Monument on crest of Ash Pond 2.

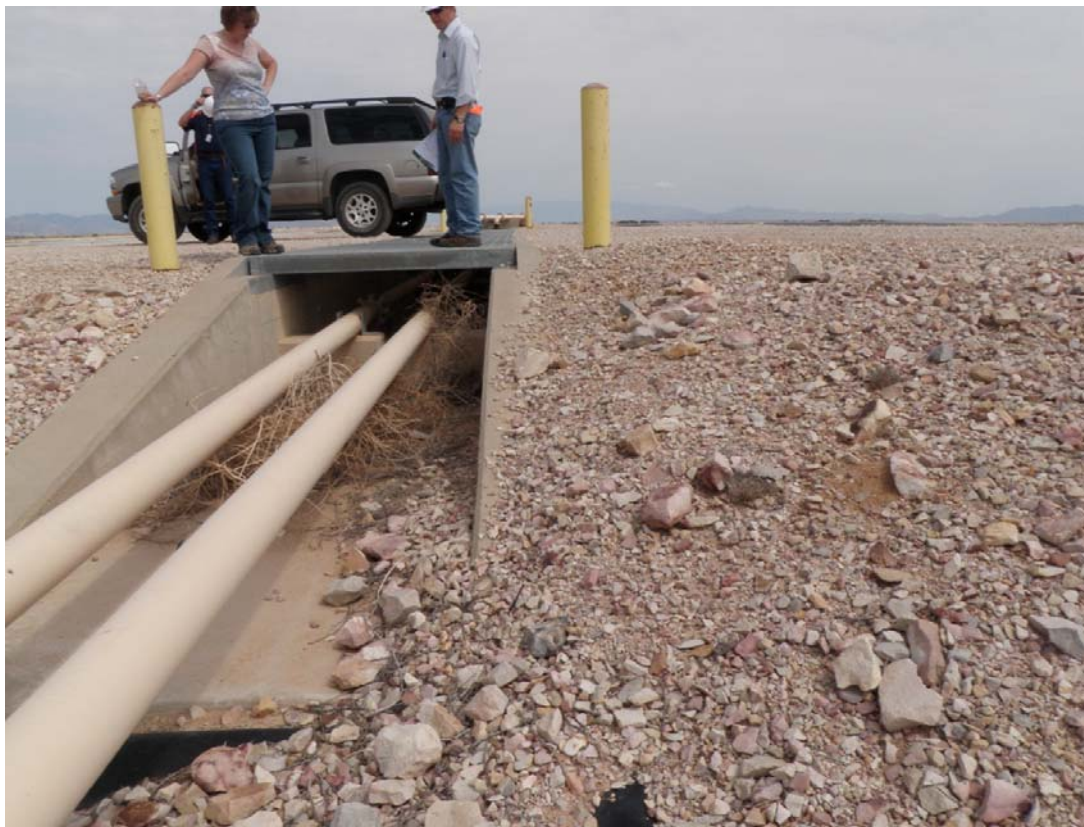
Photo 42: Pipe vault where pipes cross the crest to discharge into Scrubber Sludge Pond 1, looking north. Note the vault lacks a concrete headwall at the downstream end, which could provide a pathway to concentrate discharge of overtopping flows.

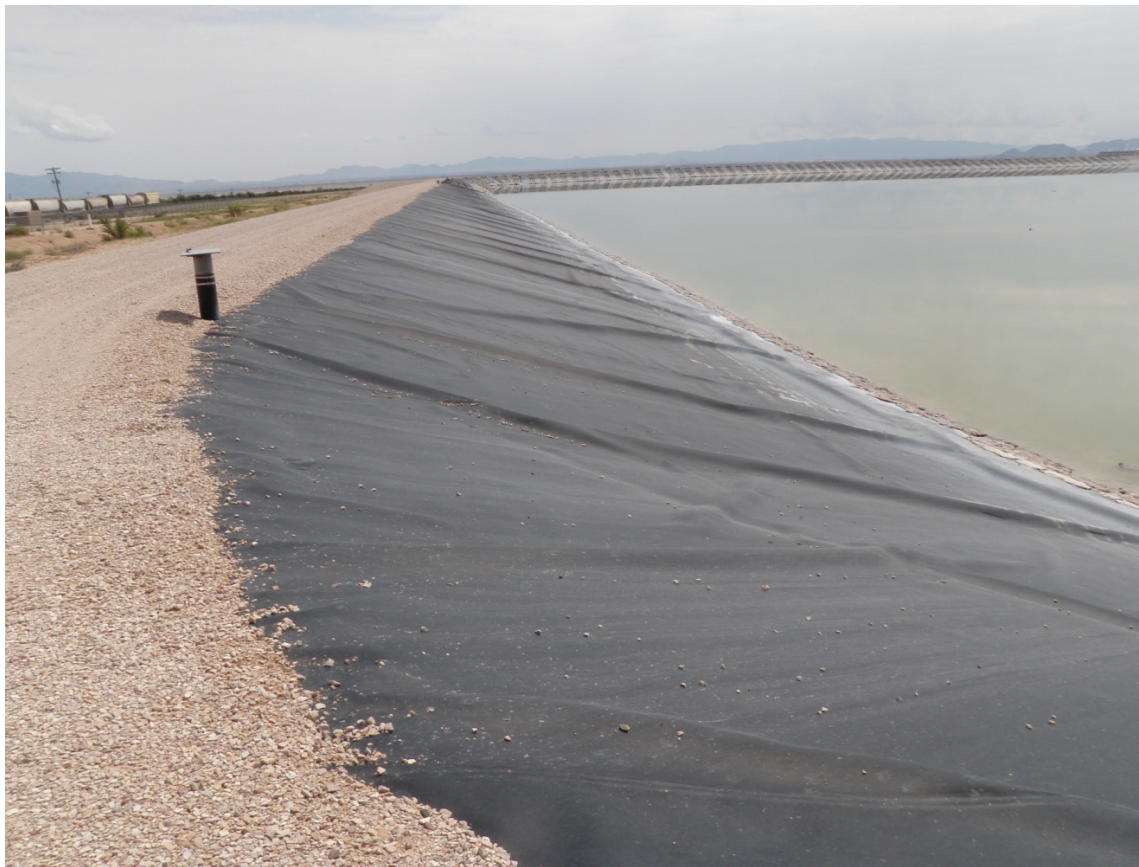
Photo 53: Upstream slope of north embankment of Scrubber Sludge Pond 2, looking east.

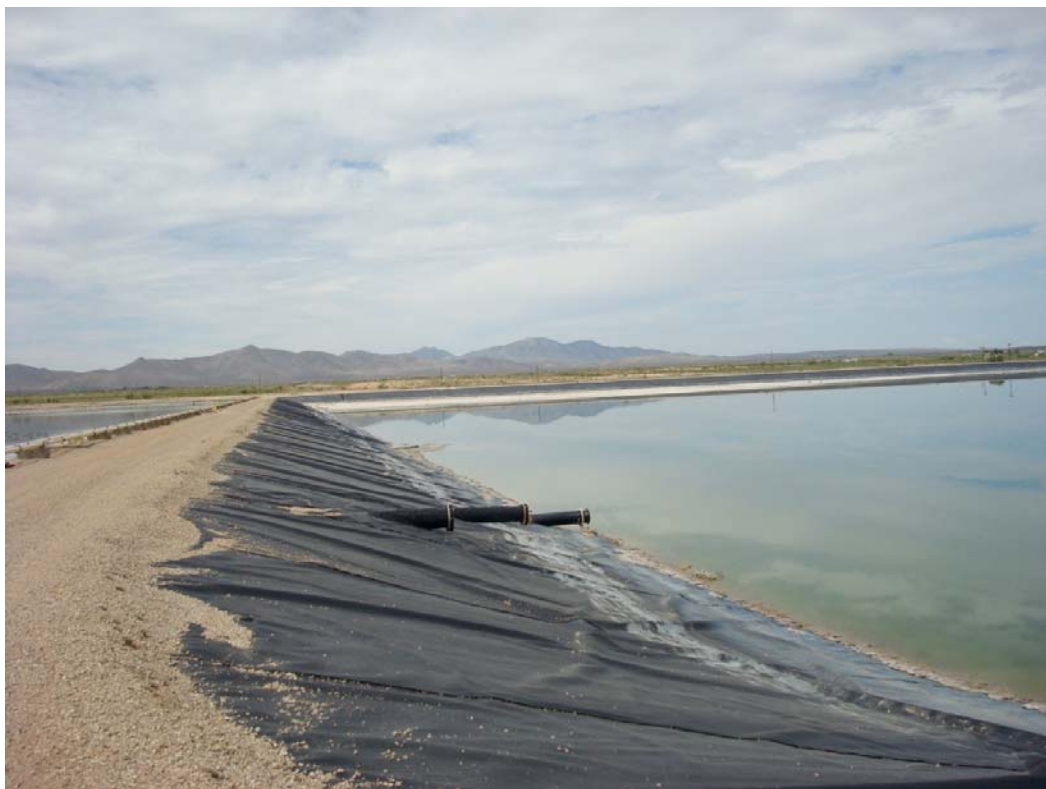
A potential outlet structure for SSP1 consists of three HDPE pipes that connect SSP1 and SSP2 at three different invert elevations (see Photo 54). The pipes are installed horizontal. At the time of the assessment, these outlet pipes were closed with blind flanges on both ends of the pipes and were not operational. These pipes can only be used to provide an outlet under specific operating conditions, such as when the water level in one pond is higher than the other pond so that a flow can be established. With the exception of these pipes, the surface sludge impoundments have no outlet. The outlet pipes appeared to be in acceptable condition and are expected to function should AEPCO choose to operate them as an outlet to discharge from SSP1 to SSP2.

Photo 54: Upstream slope of the south embankment of Scrubber Sludge Pond 2, looking west. Note 3 HDPE pipes that connect Scrubber Sludge Pond 1 and Scrubber Sludge Pond 2. The pipes were closed with blind flanges at each end.

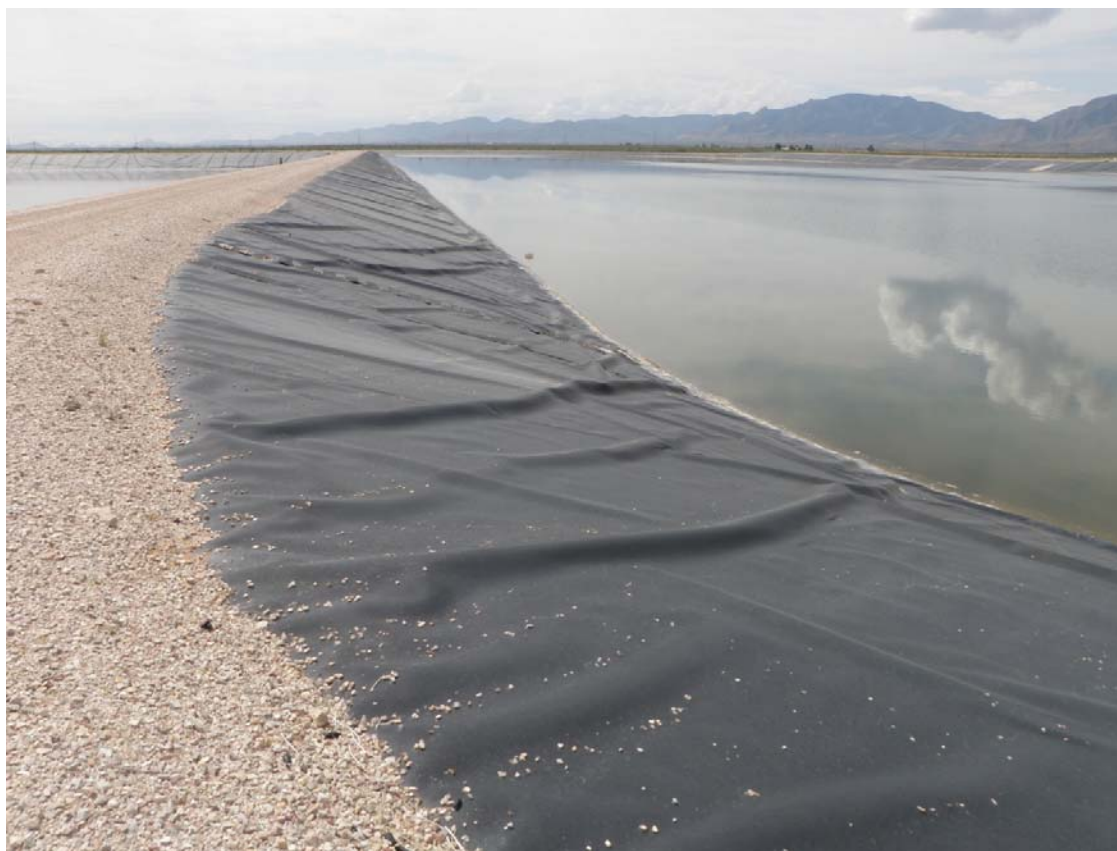
Photo 56: Upstream slope of Evaporation Pond, east embankment, looking south.

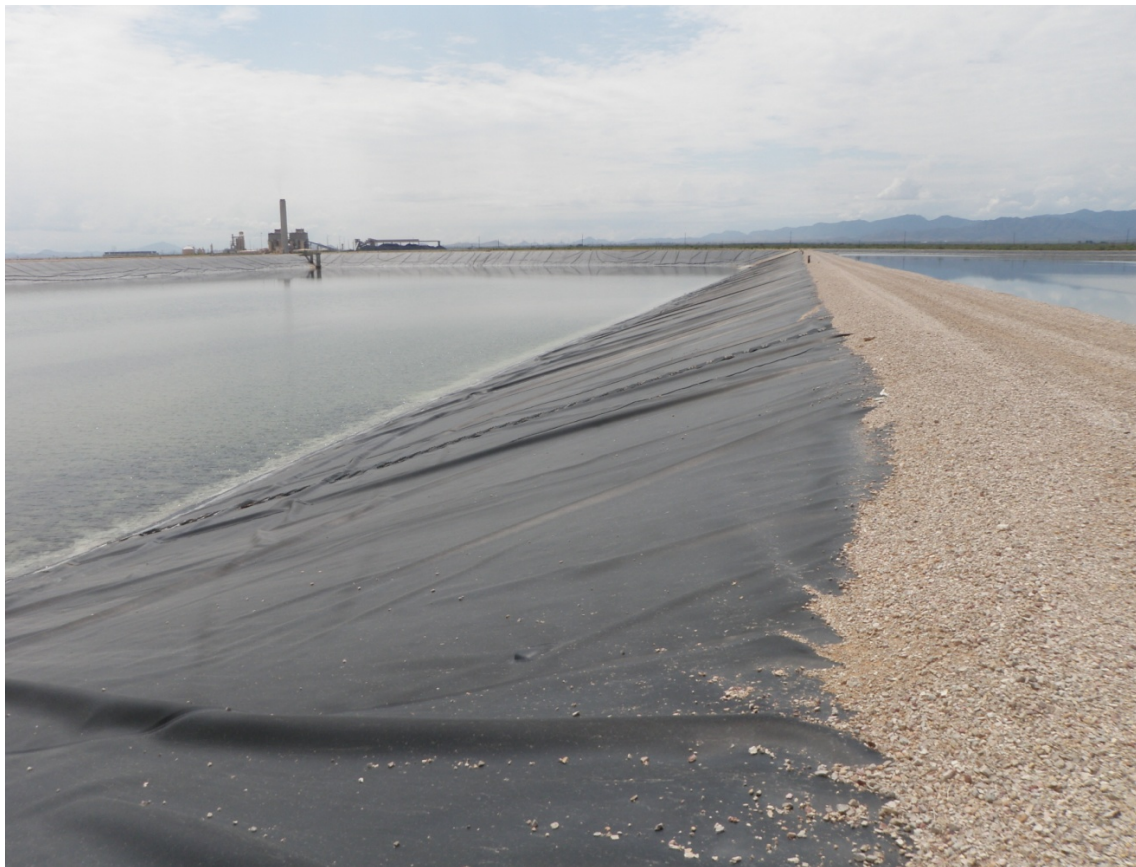
Photo 57: Upstream slope of Ash Pond 3, west embankment, looking south. Evaporation Pond is at right side of photo.

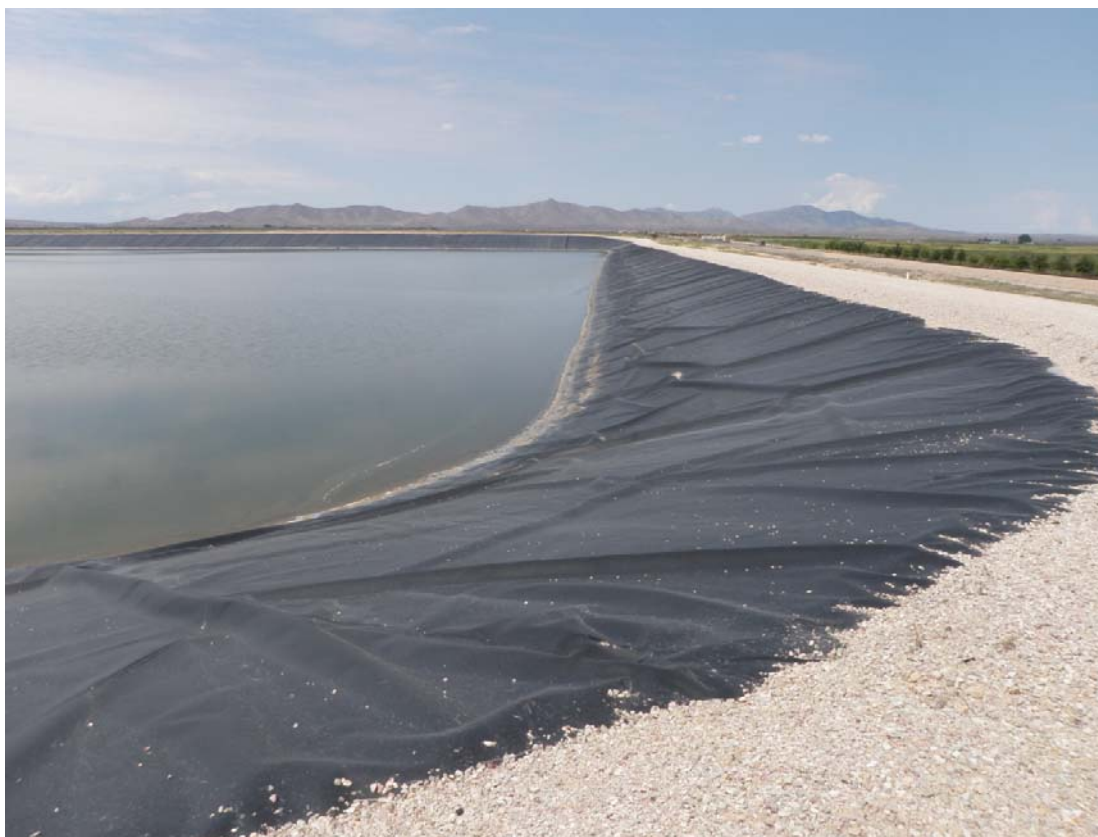
Photo 58: Upstream slope of Evaporation Pond, north embankment, looking west.

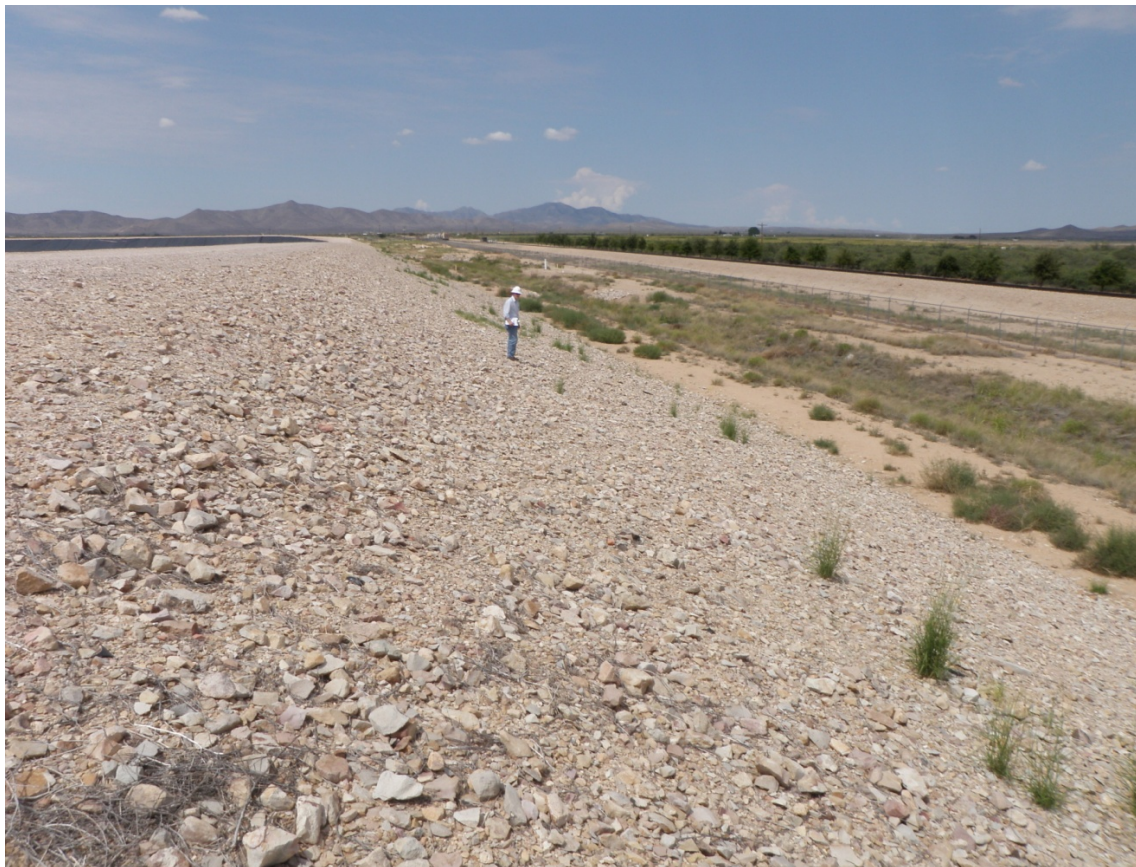
Photo 59: Downstream slope of north embankment of Scrubber Sludge Pond 2, looking west.

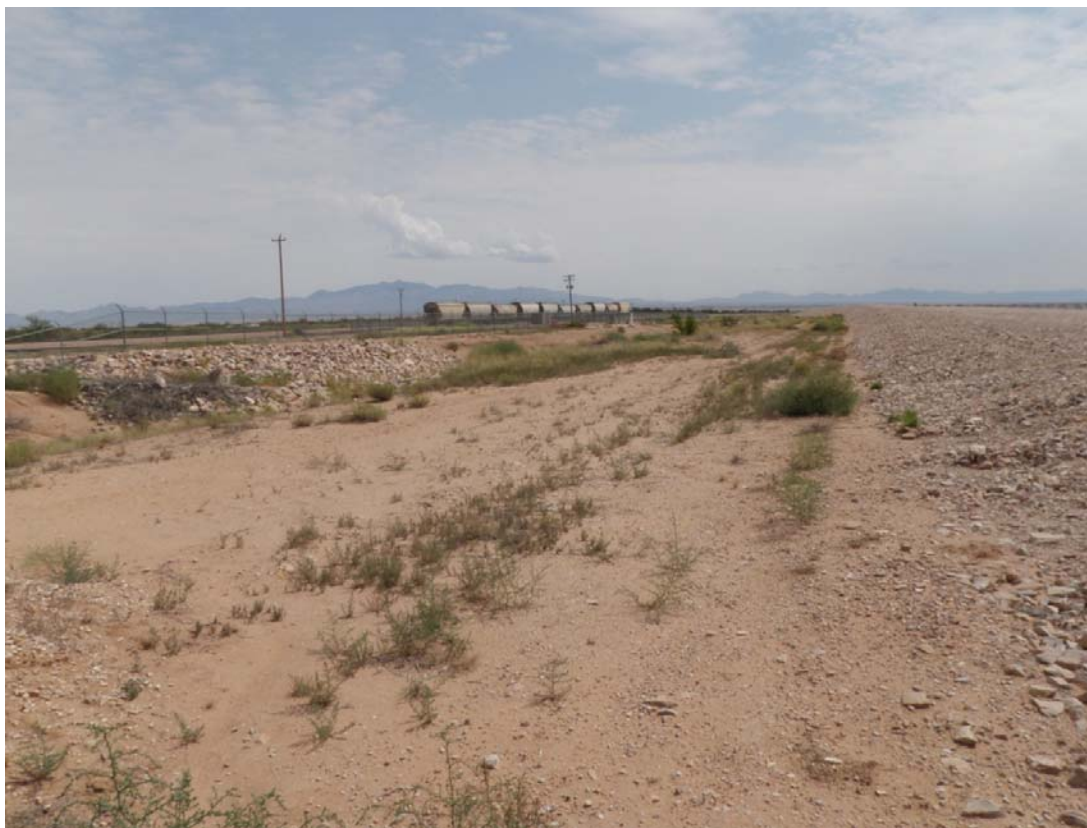
Photo 60: Downstream slope of Scrubber Sludge Pond 2, north embankment, looking east.

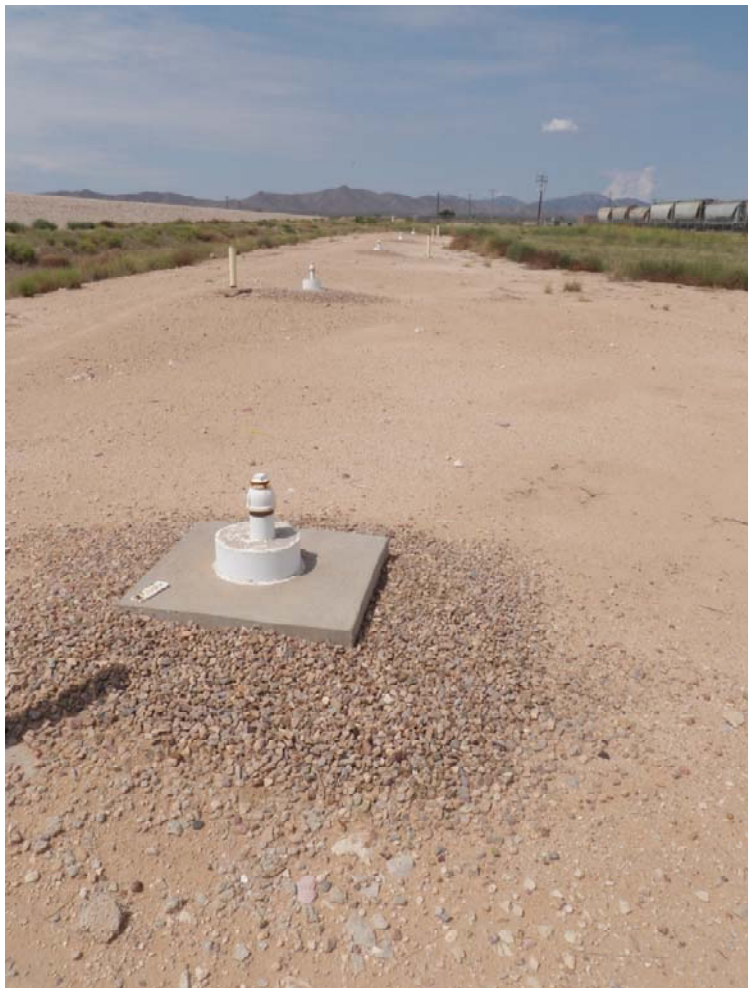
Photo 61: High precision survey monuments located in area where fissures were identified on north side of Scrubber Sludge Pond 2/ Evaporation Pond prior to construction. Note train on tracks located north of the facility.
